Intel[®] Pentium[®] III Xeon[™] Processor Specification Update

Release Date: July 2002

Order Number: 244460-037

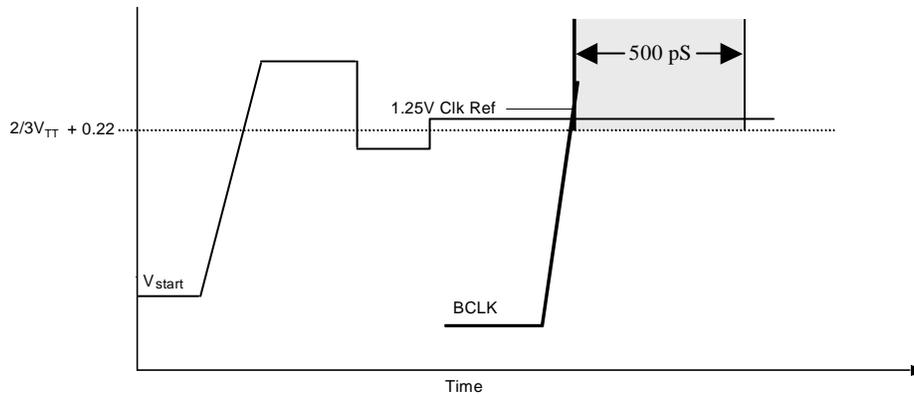
Intel has characterized the new AGTL+ AC specification for $V_{IH(MIN)}$ on the processor's RS0# signal to be: $(2/3 \cdot V_{TT}) + 0.22$ Volts within 500 picoseconds following the rising edge of BCLK crossing the 1.25-Volt threshold. See below.

Implication: The deviation from the published specification results in decreased noise margin on the RS0# processor input. This decreased noise margin has been observed to be particularly detrimental in system environments where the RS0# processor input is being driven by an I/O buffer with a pull-up device (such as a p-channel transistor) that is switched off mid-cycle. Systems that employ I/O buffers that keep the pull-up device on for the entire cycle are significantly less affected by this erratum. The reduction in noise margin may lead to the generation of BINIT# (when enabled) resulting in a system reset, otherwise this condition may lead to a system "hang" condition.

Workaround: If a system design cannot meet the specification deviation, the following areas should be carefully examined to assure that additional margin exists in order to compensate for any deficit observed with respect to the newly characterized $V_{IH(MIN)}$ specification:

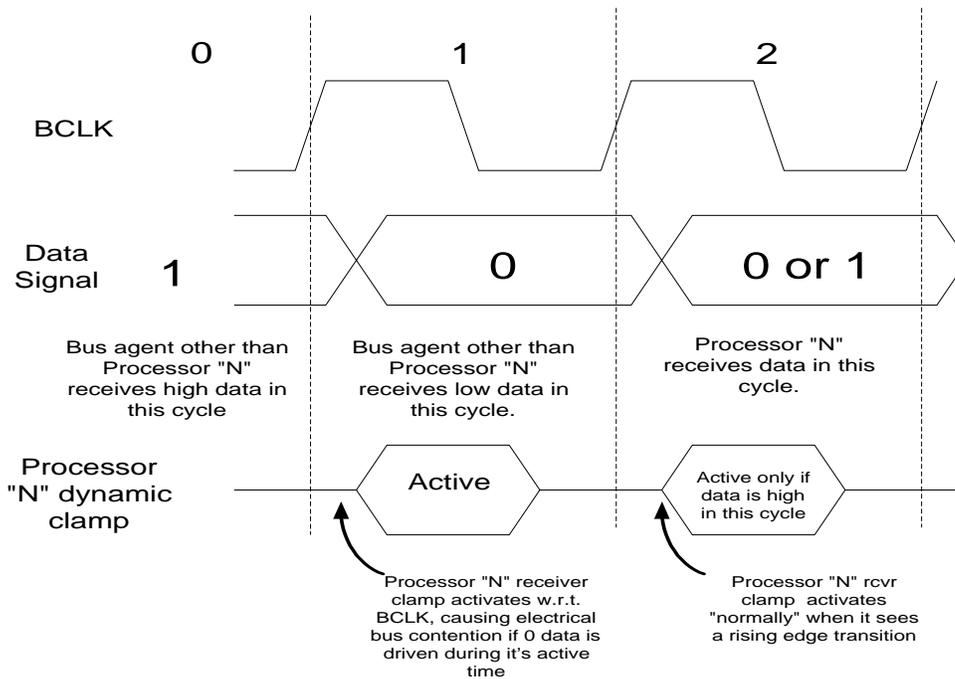
Problem: Falling edge ledge push-out and undershoot may be seen on AGTL+ data and data bus ECC signals. The AGTL+ receiver's dynamic clamp circuit activates (i.e. clamps the signal to an electrically high level) in certain cycles when data is driven to an electrically low level by another agent.

Implication: This erratum only occurs on a processor that does not receive data in that particular cycle. More specifically, this erratum only occurs when a specific processor does not receive data in the current BCLK period, but receives data in the very next period. Therefore, the processor inducing this falling edge noise (on data and data bus ECC signals) will not actually read the data in that cycle. See below for an illustration of this erratum affecting a processor denoted Processor "N". The falling edge ledges and undershoots may affect the signal quality and/or timing at agents that receive data in that cycle. Therefore, the impact of this erratum is highly dependent on system bus design.

Workaround: Evaluate system bus signal quality and timing margin at the valid receiving agent as a result of this falling edge noise. Due to dependence upon system bus design, bus layout may be evaluated to determine the need for improvements in signal quality and timing margin at the valid receiving agent as a result of this receiver-induced falling edge noise.
