hp 9000 rp3410 and rp3440 Server Errata: Important Information about your HP Server

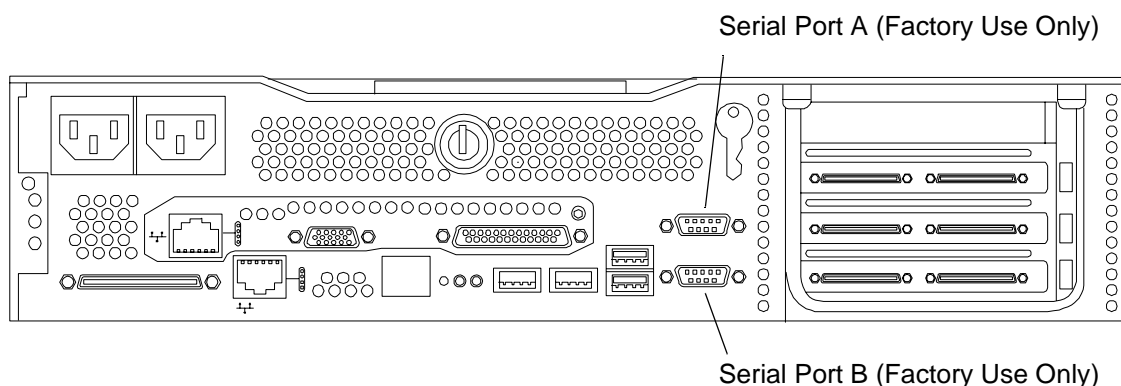
Figure 1. Rear Panel of hp 9000 rp3410/rp3440 Server

Documentation and User Guides for the hp 9000 rp3410 and rp3440 Server erroneously report the presence of a 10/100 base-T Ethernet connector on the rear panel of the Server. This connector is not present on commercially available 9000 rp3410 and rp3440 Servers. See Figure 1.
