HP Virtual Connect Firmware Upgrade Steps and Procedures

Technical white paper

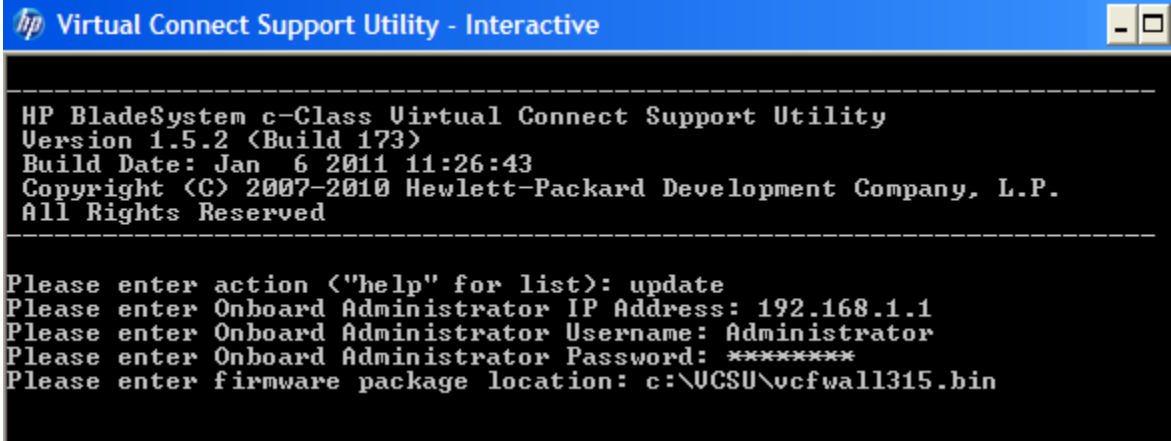
Once the VC firmware package is downloaded from the web, launch VCSU 1.5.2 or later from local Windows, Linux or HP-UX workstation.

```
hp Virtual Connect Support Utility - Interactive
-----
HP BladeSystem c-Class Virtual Connect Support Utility
Version 1.5.2 (Build 173)
Build Date: Jan 6 2011 11:26:43
Copyright (C) 2007-2010 Hewlett-Packard Development Company, L.P.
All Rights Reserved
-----
Please enter action ("help" for list): update
Please enter Onboard Administrator IP Address: 192.168.1.1
Please enter Onboard Administrator Username: Administrator
Please enter Onboard Administrator Password: *****
Please enter firmware package location: c:\VCSU\vcfwal1315.bin
```

Both the OA and VC credentials are required for the update process. The OA credentials must be Administrator equivalent credentials so that VCSU could access specific OA data to perform the upgrade.

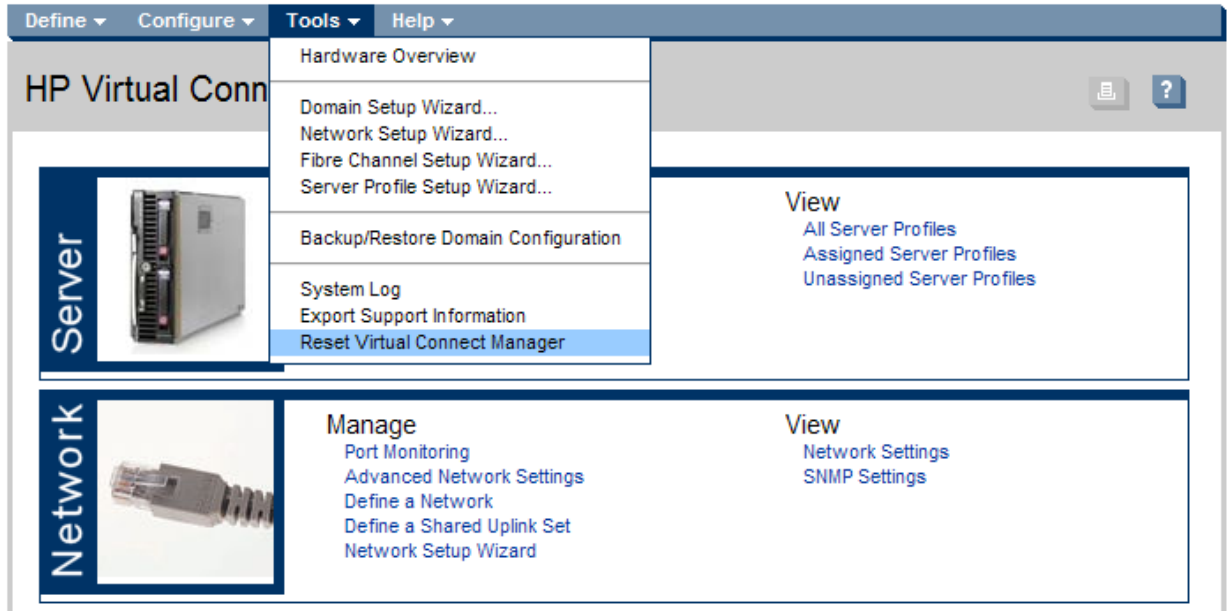
To reset the Virtual Connect Manager application running on the primary Virtual Connect Ethernet module from VC GUI, select "Tools→Reset Virtual Connect Manager".

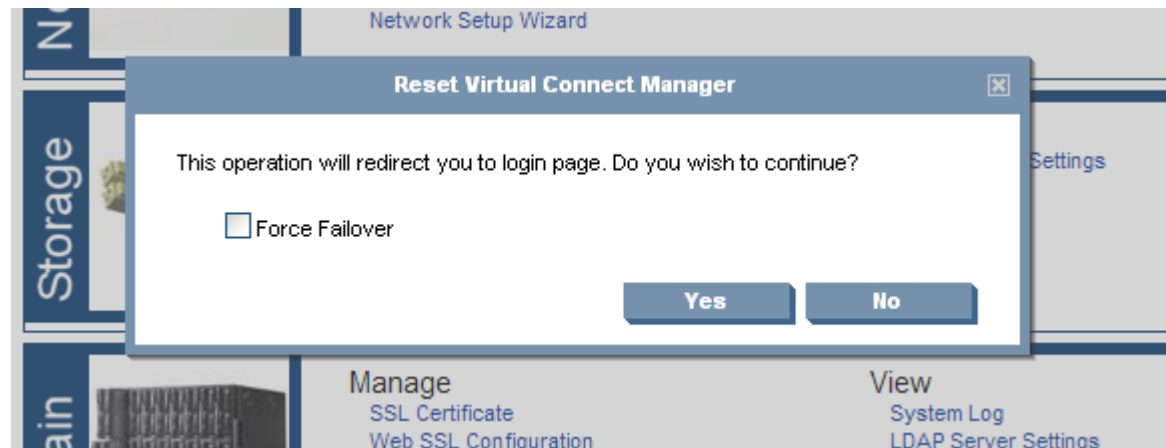
The Reset Virtual Connect Manager popup is displayed.

- If the Force Failover checkbox is selected and a Virtual Connect Ethernet module is available in the horizontally adjacent IO Bay, the GUI is redirected to that Ethernet module after the Virtual Connect Manager reset operation completes.
- If the Force Failover checkbox is not selected or a Virtual Connect Ethernet module is not available in the horizontally adjacent IO Bay, the Virtual Connect Manager restarts on the current Ethernet module, and user is presented with the logon screen for the current Ethernet module after Virtual Connect Manager reset operation completes.
- Reset times depend on the size and complexity of the VC domain configuration.

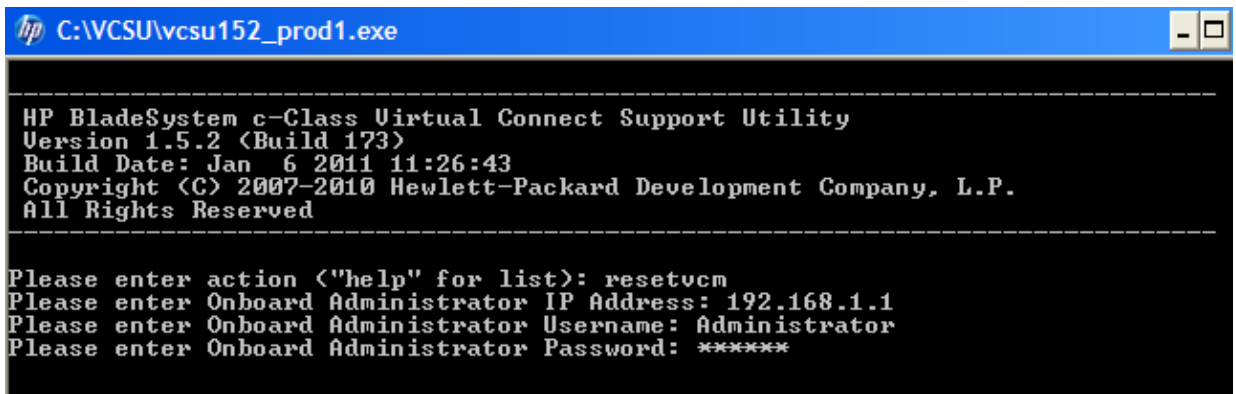
As an alternative, the "Reset VC Manager" operation may be performed using interactive mode of VCSU v1.5.2 or later:

```
HP BladeSystem c-Class Virtual Connect Support Utility
Version 1.5.2 (Build 173)
Build Date: Jan 6 2011 11:26:43
Copyright (C) 2007-2010 Hewlett-Packard Development Company, L.P.
All Rights Reserved

Please enter action ("help" for list): resetsvc
Please enter Onboard Administrator IP Address: 192.168.1.1
Please enter Onboard Administrator Username: Administrator
Please enter Onboard Administrator Password: *****
```
