## Release Notes: Version G.07.2x Operating System *for the HP Procurve Series 4100GL Switches*

These release notes include information on the following:

- Downloading switch software and Documentation from the Web
- Enhancements supported in Release G.07.2x:
  - SSLv3
  - SNMPv3
  - 802.1X Open VLAN Mode
  - SSHv2
  - IP Static Routing
  - 100-FX MTRJ GL Module (J4892A)
  - IGMPv3
  - Debug and Syslog Logging
  - Gigabit LH-LC mini-GBIC (J4860A)
- Software fix listings for the HP Procurve Series 4100GL software releases (page 11)

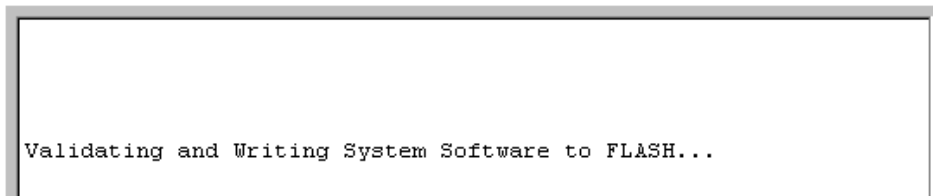
- When the switch finishes downloading the OS file from the server, it displays this progress message:

**Figure 1. Message Indicating the Switch Is Writing the Downloaded Software to Flash Memory**
